Late Failure of Left Ventricular Leads Stabilized Using the Retained Guidewire Technique in Patients Undergoing Cardiac Resynchronization Therapy

Elena Arbelo, Antonio García-Quintana, Eduardo Caballero, Antonio Delgado, Celestina Amador, Javier Suárez de Lezo, Marta Díaz-Escofet, and Alfonso Medina

Servicio de Cardiología, Hospital Universitario de Gran Canaria Dr. Negrín, Las Palmas de Gran Canaria, Spain

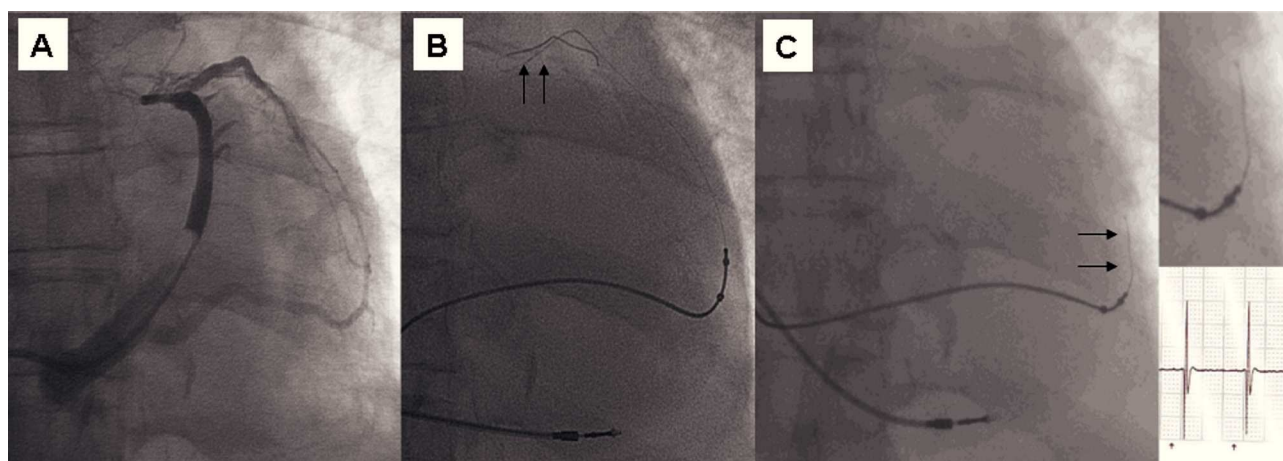
The manoeuvre consists of exteriorising of a hydrophilic guidewire (Whisper®, Guidant Corp., MN, United States) 10-15 mm beyond the electrode tip, its proximal portion is cut and it is left inside the electrode. The polymer cover, acting as insulation, did not change the performance of the electrode in the operation period (Figure 1).

Figure 1. Retained guidewire technique. A: occlusive sinus venography that shows a vein with an output close to the ostium of the coronary sinus and the stretch in the lateral left ventricular region. B: final end of the guidewire and the route of the electrode. C: to avoid phrenic stimulation and stabilise the electrode the retained guidewire technique was used.

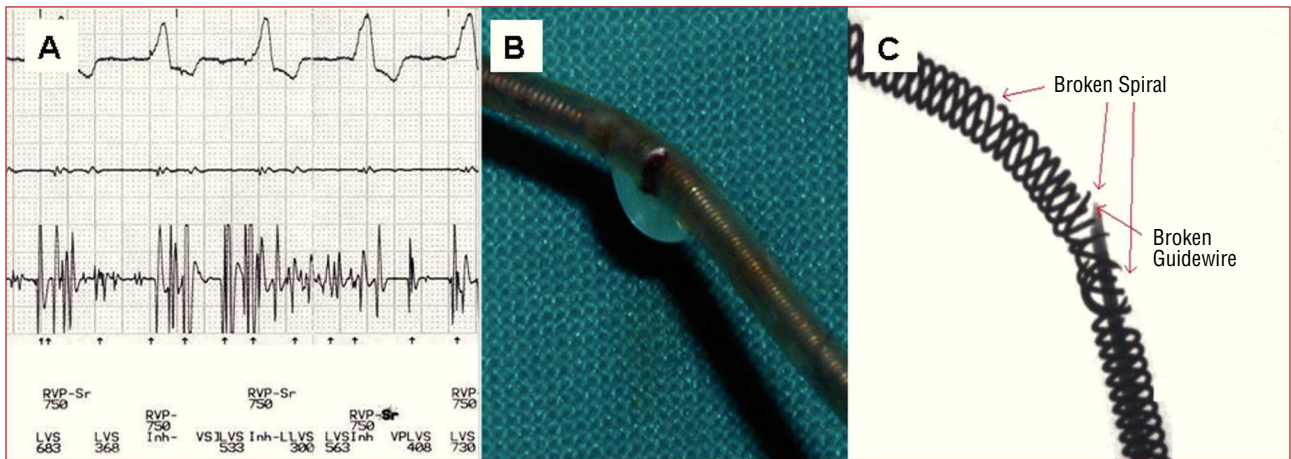
were observed in the parameters of the sensing and stimulation with the appearance of noise in the LV channel and capture failure (Figure 2A). Coincidentally, a marked increase in impedance was recorded (>2000 Ω).

The reprogramming of a pseudobipolar configuration (point LV at ring RV) permitted biventricular stimulation of one patient, while in the other 2 it was necessary to explant the damaged electrode with the guidewire inside, which showed macroscopic evidence of breakage at different levels (Figure 2B). In one of the cases, those which were sent to the laboratory for analysis were deformed and the conductor spirals were broken. It was shown that the internal and external insulating layers were damaged, as was the segment of the guidewire inside the electrode (Figure 2C), and found the guidewire broken at this level.

Figure 2. Failure of the retained guidewire technique. A: follow up after 1 year, a noise was recorded. B: the electrode and the guidewire within were explanted and the breakage was observed. C: laboratory analysis showing the broken spirals and the guidewire inside.

The retained guidewire technique has been described for stabilising the electrode in the selected position by incorporating a hydrophilic guidewire through the light of the electrode.¹⁰ de Cock et al¹⁰ refer to an average follow up of 6 months in 6 patients without having seen any deterioration in the electrode. However, in the light of the results of this technique in 3 patients in this series, with late deterioration of the LV electrode, in accordance with the findings reported by Nägele et al,¹² the use of this technique is not recommended for stabilising purposes. It is possible that the guidewire inside the electrode is the cause of the friction sustained in the internal spiral, leading to the fracture of the electrode.

The function of the guidewires is to give support during the placement of the electrode; they are not designed to be implanted. Taking into consideration that the guidewire is less flexible than the electrode, it is possible that this may break due to the repeated movements of the patients, which may damage the insulating layers and the spirals of the electrode. The findings of the laboratory examining the explanted electrode, showed the damage at the same level as the break in the guidewire, making it is more likely that the damage to the spirals and insulating layers is caused by the ends of the fractured guide. This deterioration also led to the clinically observed noise caused by friction of the conductor spirals. It is not expected that the results of this manoeuvre will have a different result if other types of electrodes are used.

Migration of the LV electrode continues to be a problem in CRT, which can appear in up to 10%-12% of implants.¹⁻⁴ However, based on the findings of this series, we do not advise the use of this technique, not only because of the failure of LV uptake with loss of biventricular stimulation, but also safety as it can cause vascular perforation by the ends of the damaged guide. It is necessary to develop new types of electrode with alternative adherence systems

Even though it has been described as a useful technique for stabilising the electrode, the cases presented indicate that the retained guidewire should not be used as it leads to a deterioration in the electrode during monitoring.
