Image in cardiology

Prosthetic ring dehiscence during mitral valve-in-ring

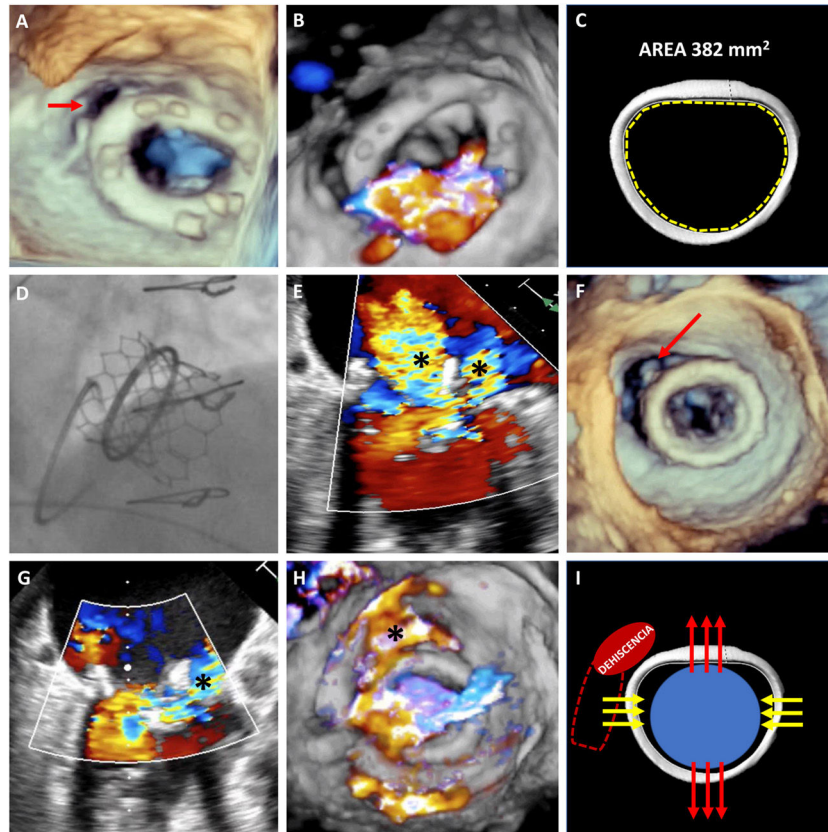
Figure 1.

A 73-year-old woman who had undergone mitral and tricuspid annuloplasty with a 28-mm Physio mitral ring and a 34-mm MC3 tricuspid ring (Edwards Lifesciences, USA) developed severe symptomatic mitral regurgitation with minor anterolateral ring dehiscence but no evidence of paravascular leakage (PVL) (figure 1A,B, arrow, and video 1 of the supplementary data). Because of the patient's comorbidities, it was decided to perform percutaneous mitral valve-in-ring implantation. The internal area of the ring estimated by computed tomography (CT) was 382 mm² (figure 1C), which was compatible with a 23-mm Edwards SAPIEN-3 valve. The Mitral Valve-in-Valve (ViV) application, however, recommended a 26-mm ring (figure 1D). The larger ring was eventually used but resulted in intraprosthetic regurgitation, due to incomplete closure of the leaflets, and periprosthetic regurgitation (figure 1E, asterisks, and videos 2 and 3 of the supplementary data). The intraprosthetic regurgitation was corrected with a 28-mm balloon, but this caused a considerable increase in the size of the dehiscence and severe PVL (figure 1F-H, arrow and asterisks, and videos 4–6 of the supplementary data). The patient underwent surgical repair with a favorable outcome. Percutaneous repair was ruled out because of the size of the defect (> 180°) and because it had probably been caused by annular tear.

The present case illustrates 2 potential complications of mitral valve-in-ring implantation that could have an unfavorable outcome. The difference between the size of the ring observed by CT and that recommended by the ViV application resulted in the use of an oversized ring, which might have altered the mobility of the heart valve leaflets. It will also have increased the tension on an already dehiscenced ring in a critical area (figure 11), with worsening of the situation after postdilation. This case highlights the importance of correct sizing and of evaluating different factors that can affect the outcome of mitral valve-in-ring implantation. CT appears to provide the most reliable estimate of ring size, but more studies are needed to confirm this hypothesis. We obtained written informed consent from our patient for the publication of this case.
