Prosthetic Aortic Valve Thrombosis After Left Ventricular Assist Device Implantation

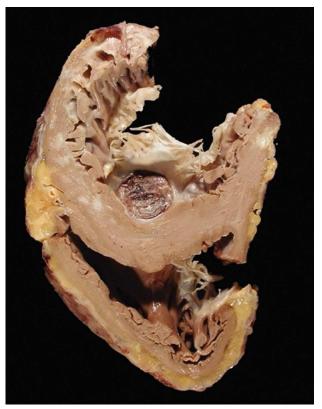
Figure 1.

The most frequent and feared complications associated with LV assist devices are thromboembolic events. Despite proper anticoagulation, the absence of flow through the aortic valve led to thrombotic formation and complete thrombosis of the mechanical prosthesis (Figures 1 and 2). Macroscopic images of the aortic valve prosthesis viewed from the LV are presented.
