Long-term Pacemaker Lead Malposition. Role of Echocardiography

Malposición de catéter de marcapasos durante 9 años. Rol del ecocardiograma

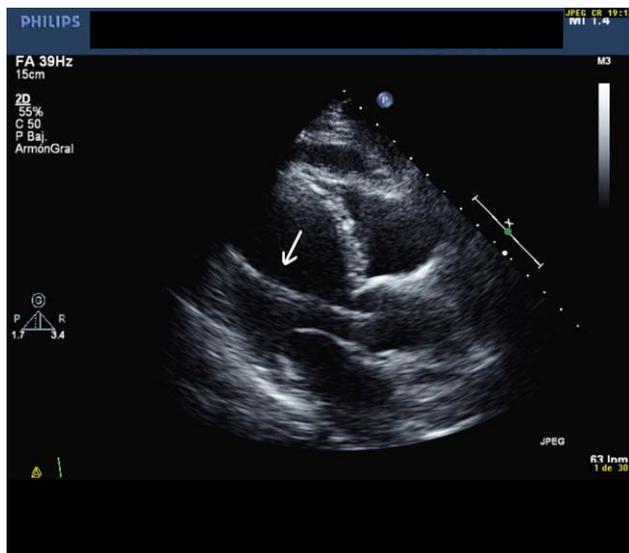
Figure 1. Long axis parasternal transthoracic echocardiography. The arrow indicates the pacemaker lead in the left ventricular cavity passing through the aortic valve.

We describe the clinical, electrocardiographic (ECG), X-ray and echocardiographic findings of a 75-year-old woman referred to our diagnostic imaging unit for echocardiography to determine a possible source of embolization, after discovery of basal ganglia infarction in a cranial tomography requested for dizziness. The patient had received a VVI pacemaker implant 9 years earlier, indicated for third-degree atrioventricular block. The ECG showed pacemaker rhythm with complete right bundle branch block morphology. A lateral chest X-ray showed the pacemaker lead was in a posterior location. Transthoracic echocardiography, in parasternal and apical windows, showed left heart cavities were normal, with 60% ejection fraction and mild aortic regurgitation. We determined that the pacemaker lead passed through the aortic valve (Fig. 1) and that the electrode had fixed in the mid portion of the left ventricular free wall. No signs of vegetations or thrombus
