Image in cardiology

# Peri-stent Ulcer Like Appearance Late After Sirolimus-eluting Stent Implantation

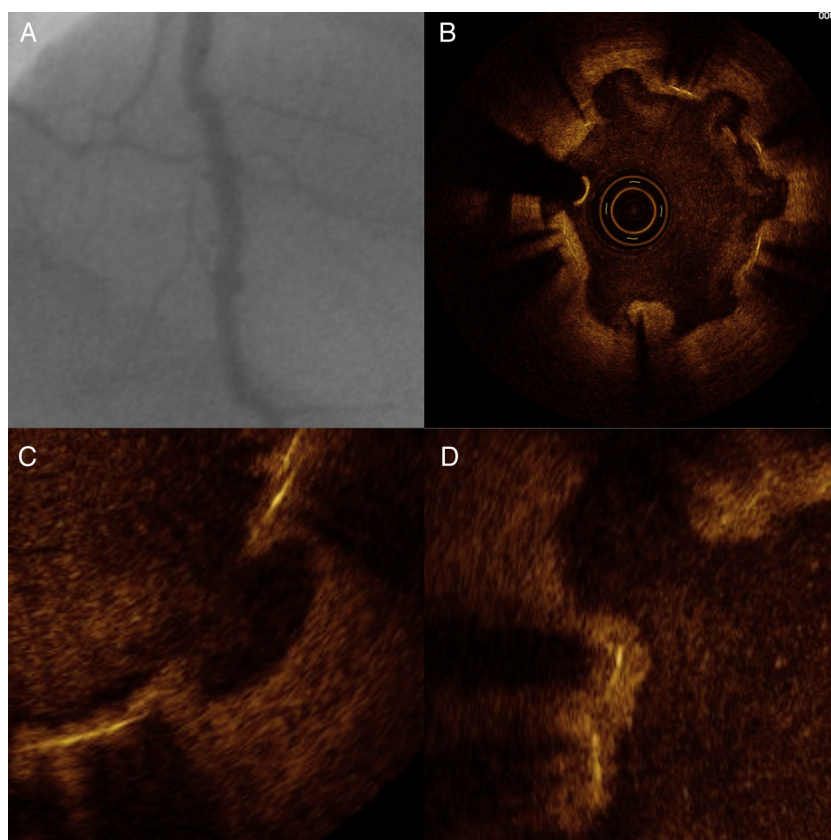
Figure 1.

A 41-year-old male smoker with hypertension underwent diagnostic angiography for angina on exertion. The study showed chronic occlusion of the proximal left anterior descending artery (LAD) with collateral circulation from the right coronary artery. Stress echocardiography showed viability and inducible ischemia in the affected territory. Angioplasty was performed, with implantation of 4 sirolimus-eluting stents (SES) of 2.25×23, 2.25×28, 2.5×13, and 2.5×23 mm, with angiographic success. Eighteen months later, the patient was readmitted for exertional angina, and coronary angiography was again performed. The LAD was patent, but had an irregular appearance with slow clearance along the length of the treated segment (Fig. 1A). Optical coherence tomography (Fig. 1B) showed vascular wall retraction and an ulcerated appearance around the stent. The struts were not affected and, for the most part, showed re-endothelization (Fig. 1C and D). The vessel lumen showed no significant stenosis.

Contrast retention on angiography following implantation of a drug-eluting stent has been associated with intracoronary imaging findings of late stent malapposition. The vascular wall reaction to SES has been described as “peri-stent ulcer like appearance” (PSUA). It has a reported incidence of up to 50% in small series and is speculated to be a harbinger of late malapposition.
