Image in cardiology

An Intracardiac Foreign Body, and a Few More

Francisco Toledano,\* Martín Ruiz-Ortiz, and Dolores Mesa

Servicio de Cardiología, Hospital Universitario Reina Sofía, Córdoba, Spain

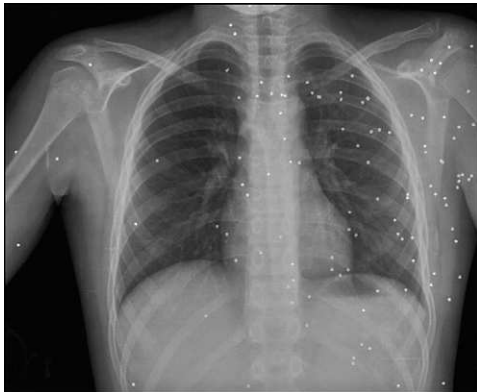
Figure 1.

A 14-year-old boy was taken to the emergency department following a firearm accident, in which he sustained multiple BB shot wounds to the neck, face, and chest. Surprisingly, he did not present signs of hemodynamic instability during hospitalization and only required drainage of a bilateral hemothorax. The chest X-ray performed just before hospital discharge showed multiple BB (Fig. 1). Figure 2 and the video provide a short-axis parasternal view of the follow-up echocardiography, in which a BB can be seen lodged in the interventricular septum (arrowhead), with the corresponding acoustic shadow. The initial electrocardiogram (Fig. 3) showed no alterations in interventricular conduction, as might have occurred considering the location of the BB. Conservative management was decided for the intracardiac foreign body, with the first follow-up visit at 1 month after hospital discharge.
