Image in cardiology

# Iatrogenic Occlusion of the Circumflex Artery: Intracoronary Image

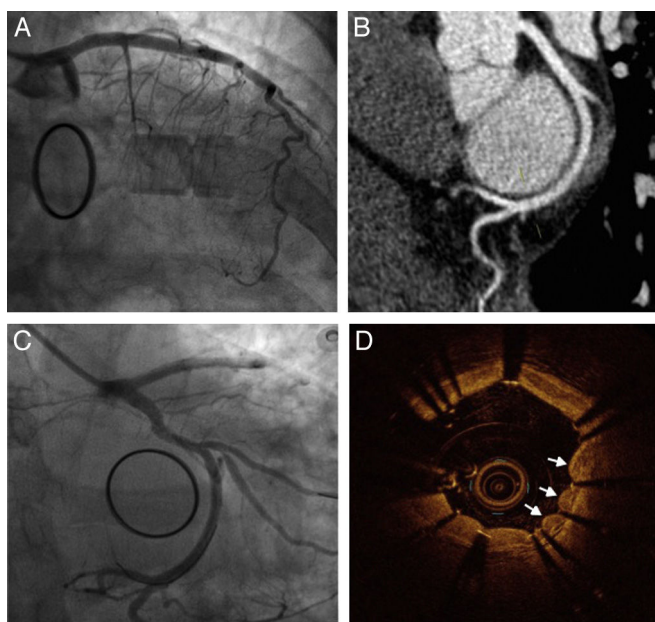
Figure.

The patient was a 51-year-old woman who was being studied after having a middle cerebral artery stroke. Echocardiography resulted in a diagnosis of mitral valve papillary fibroelastoma, and the decision was made to operate on the valve. Following resection of the fibroelastoma, valve reconstruction, and ring implantation, intraoperative ultrasound revealed the presence of moderate mitral regurgitation, and we decided to replace the mitral valve with a mechanical prosthesis. During the immediate postoperative period, the patient was found to have hemodynamic instability and ST-segment elevation in leads I, III, and aVL. Emergency coronary angiography showed occlusion of the mid circumflex artery (Cx) (Figure A) that had not been observed in the preoperative coronary angiography (Figure B). A guidewire was advanced and, despite considerable difficulty, it was made to cross the region of the lesion with a balloon; high-pressure predilatation was performed with 2-mm and 2.5-mm balloons and adequate expansion was achieved, but there was immediate elastic retraction. Finally, a 3 × 28-mm drug-eluting stent was implanted, with good angiographic results (Figure C). Optical coherence tomography revealed a peculiar scalloped aspect around the stent struts (Figure D, arrows), which indicated extrinsic compression of the coronary artery and confirmed the diagnosis of Cx occlusion due to compression/traction of the surgical suture.

The Cx runs along the anterolateral commissure, and the coronary sinus is adjacent to the annulus next to the posterior mitral leaflet, both in the atrioventricular groove. Thus, it is possible to damage the Cx during mitral valve annuloplasty or replacement. This has been reported more often with left dominant coronary artery circulation (as in our patient, Figure B) or codominance, as there is less distance between the vessel and the annulus.
