ECG Contest

Response to ECG, December 2016

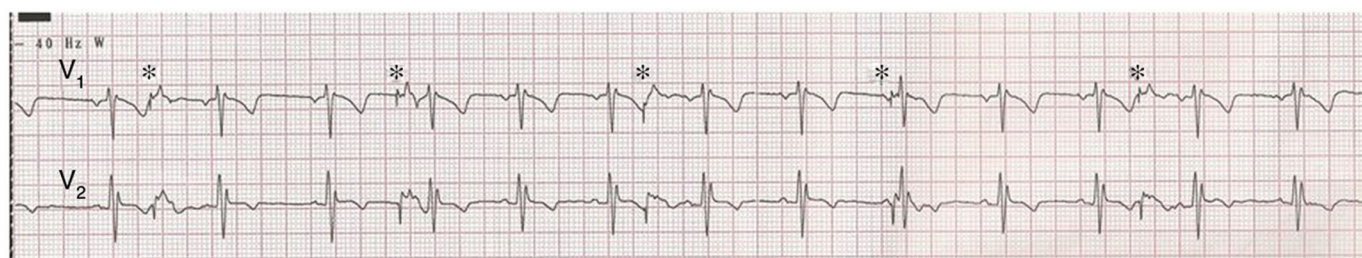
Figure 1.

The electrocardiogram showed sinus P waves at a heart rate of about 75 bpm, with a normal PR interval, 1:1 conduction, and QRS morphology indicative of incomplete right bundle branch block. In addition, pacing spikes of the implantable cardioverter defibrillator (ICD) (Figure 1, asterisks) were seen at a heart rate of about 30 bpm (normally the back-up pacing heart rate used in ICD programming for patients not requiring cardiac pacing), compatible with a ventricular sensing failure. These spikes provoked a heterogeneous action potential morphology that had no effect on the atrial and ventricular cycles, indicating capture of an extracardiac structure. Chest radiography (Figure 2) showed dislodgement of the lead toward the pectoral region due to apparent rotation of the device on its sagittal axis, which would produce capture of the chest muscles (correct answer, no. 1).
