## Image in cardiology

# Right Ventricular Pseudoaneurysm After Percutaneous Tricuspid Valve-in-valve Implantation

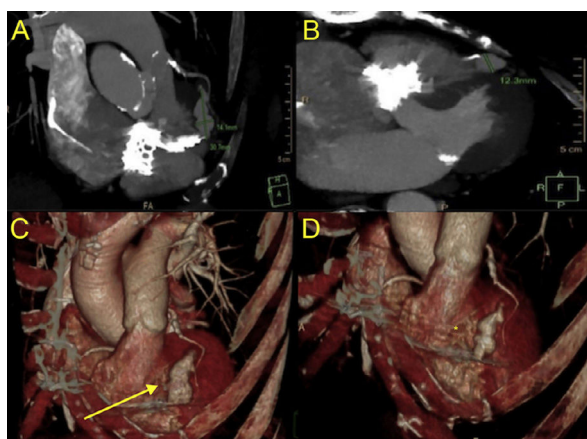
Figure 1.

Multislice computed tomography (MSCT) confirmed the presence of a pseudoaneurysm with a dimension of 30 x 14 mm in coronal view (Figure 1A) and a neck of 12 mm in long-axis view (Figure 1B). Right ventricular systolic pressures measured by echocardiography increased to 55 mmHg and MSCT at 9 days showed an increase in pseudoaneurysm size (arrow in Figure 1C) compared with postprocedural MSCT (asterisk in Figure 1D).

The likely mechanism for the pseudoaneurysm was increased pacemaker lead tension resulting from fixation of the ventricular lead between prostheses. Prevention of this complication requires careful positioning of the valve, leaving sufficient slack between the tricuspid ring and the point of the right ventricle.

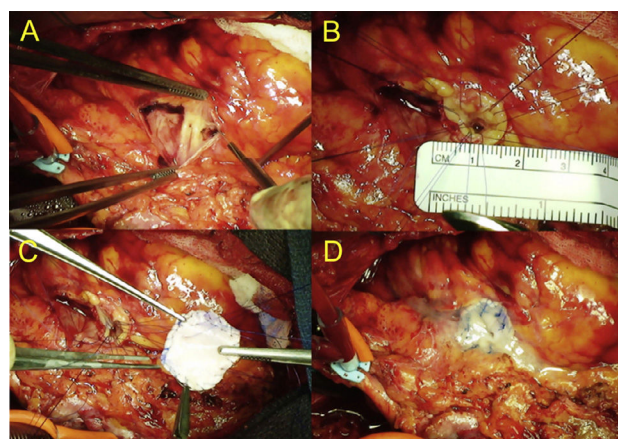
Figure 2.

Due to the risk of rupture in the setting of increased right ventricular pressures and pseudoaneurysm size, surgical repair was successfully performed. Intraoperative images of pseudoaneurysm repair show the false aneurysm opened by the scalpel in the right ventricle (Figure 2A), crossing points around the break (diameter 2.5 mm) (Figure 2B), double patch (Dacron + bovine pericardium) and "U" crossing points in the patch (Figure 2C) and final view after bonding the patch (Figure 2D).
