Image in cardiology

# Prosthetic ring dehiscence during mitral valve-in-ring

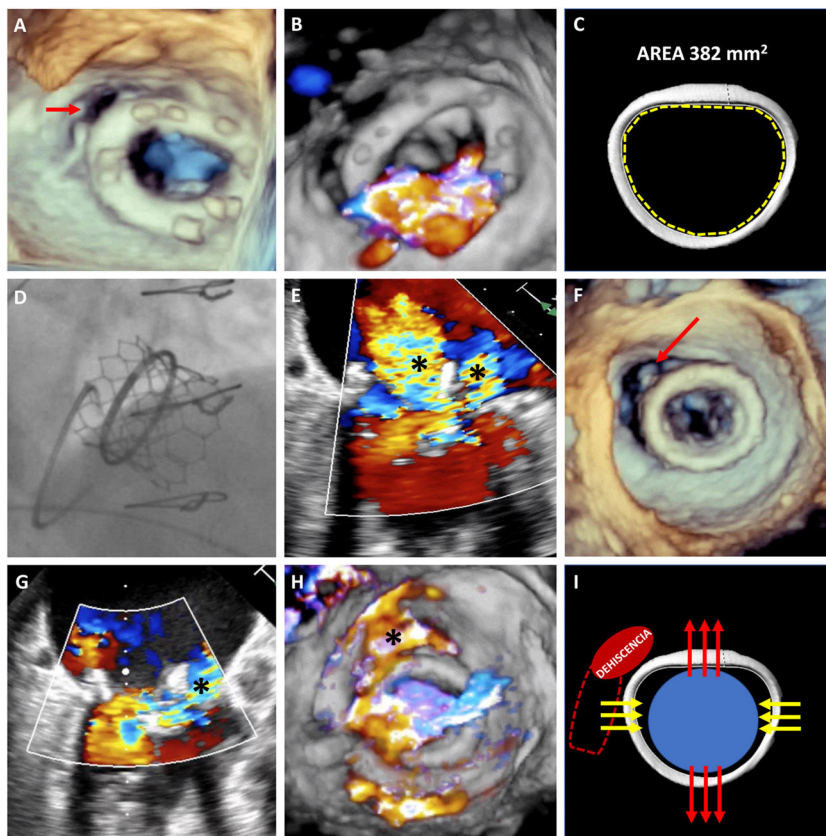
Figure 1.

A 73-year-old woman who had undergone mitral and tricuspid annuloplasty with a 28-mm Physio mitral ring and a 34-mm MC3 tricuspid ring (Edwards Lifesciences, USA) developed severe symptomatic mitral regurgitation with minor anterolateral ring dehiscence but no evidence of paravascular leakage (PVL) (figure 1A,B, arrow, and video 1 of the supplementary data). Because of the patient's comorbidities, it was decided to perform percutaneous mitral valve-in-ring implantation. The internal area of the ring estimated by computed tomography (CT) was 382 mm<sup>2</sup> (figure 1C), which was compatible with a 23-mm Edwards SAPIEN-3 valve. The Mitral Valve-in-Valve (ViV) application, however, recommended a 26-mm ring (figure 1D). The larger ring was eventually used but resulted in intraprosthetic regurgitation, due to incomplete closure of the leaflets, and periprosthetic regurgitation (figure 1E, asterisks, and videos 2 and 3 of the supplementary data). The intraprosthetic regurgitation was corrected with a 28-mm balloon, but this caused a considerable increase in the size of the dehiscence and severe PVL (figure 1F-H, arrow and asterisks, and videos 4–6 of the supplementary data). The patient underwent surgical repair with a favorable outcome. Percutaneous repair was ruled out because of the size of the defect (> 180°) and because it had probably been caused by annular tear.

The present case illustrates 2 potential complications of mitral valve-in-ring implantation that could have an unfavorable outcome. The difference between the size of the ring observed by CT and that recommended by the ViV application resulted in the use of an oversized ring, which might have altered the mobility of the heart valve leaflets. It will also have increased the tension on an already dehiscenced ring in a critical area ([figure 11](#)), with worsening of the situation after postdilation. This case highlights the importance of correct sizing and of evaluating different factors that can affect the outcome of mitral valve-in-ring implantation. CT appears to provide the most reliable estimate of ring size, but more studies are needed to confirm this hypothesis. We obtained written informed consent from our patient for the publication of this case.
