Virtual Histology of a Post-angioplasty Intramural Hematoma

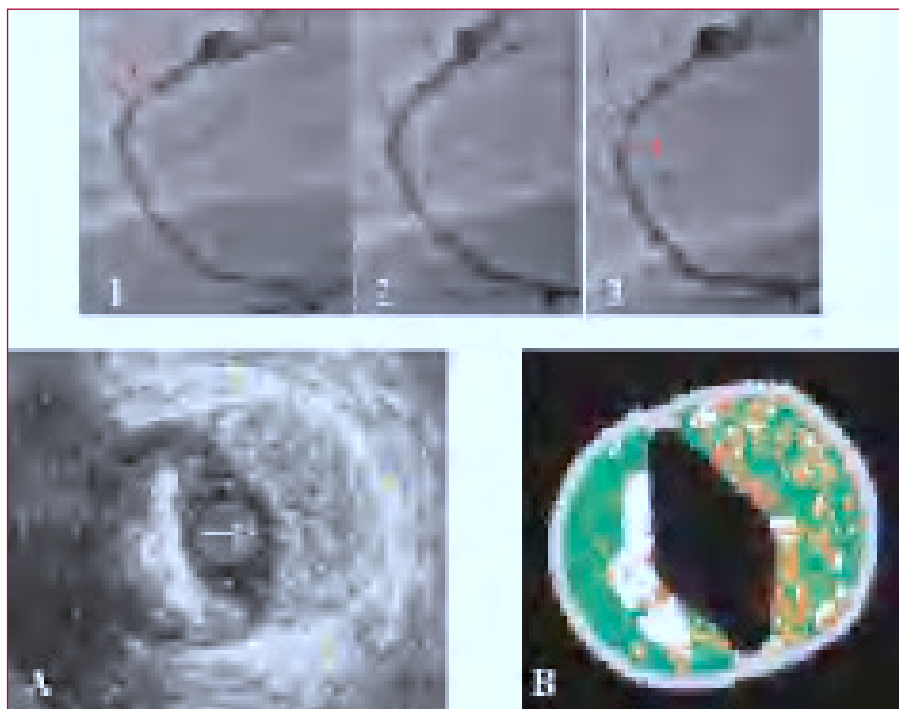
Figure 1.

A 64-year-old man underwent coronary angiography for exertional angina with severely positive ischemia tests. The study showed a severe, calcified, focal lesion in the right coronary artery (Figure 1-1). An attempt was made to assess the lesion with intravascular ultrasound (IVUS), but the catheter could not cross it; however, the procedure did reveal a superficial calcification on the plaque, with an angular extension of around 300°.

With the use of a 3-mm balloon inflated to 18 atm, the lesion was dilated (Figure 1-2); nonetheless, progressive occlusion of the vessel was seen just distal to the original lesion in the confirmatory angiography immediately after the procedure (Figure 1-3). Intravascular ultrasound

was performed and at the same location an image was seen consistent with a mural hematoma facing a calcified plaque (Figure 1A). The image provided by radiofrequency analysis (Virtual Histology, Volcano Inc.) showed a diffusely speckled “necrotic core” pattern over the entire thickness (Figure 1B). Although it is not validated in this context, this technique may be able to specifically characterize the fresh blood collection of typical to a mural hematoma.
