Image in cardiology

## Culotte Technique With a Bioresorbable Vascular Scaffold: 12 Months' Follow-up

Lucía Vera Pernasetti,\* Hipólito Gutiérrez, and Benigno Ramos

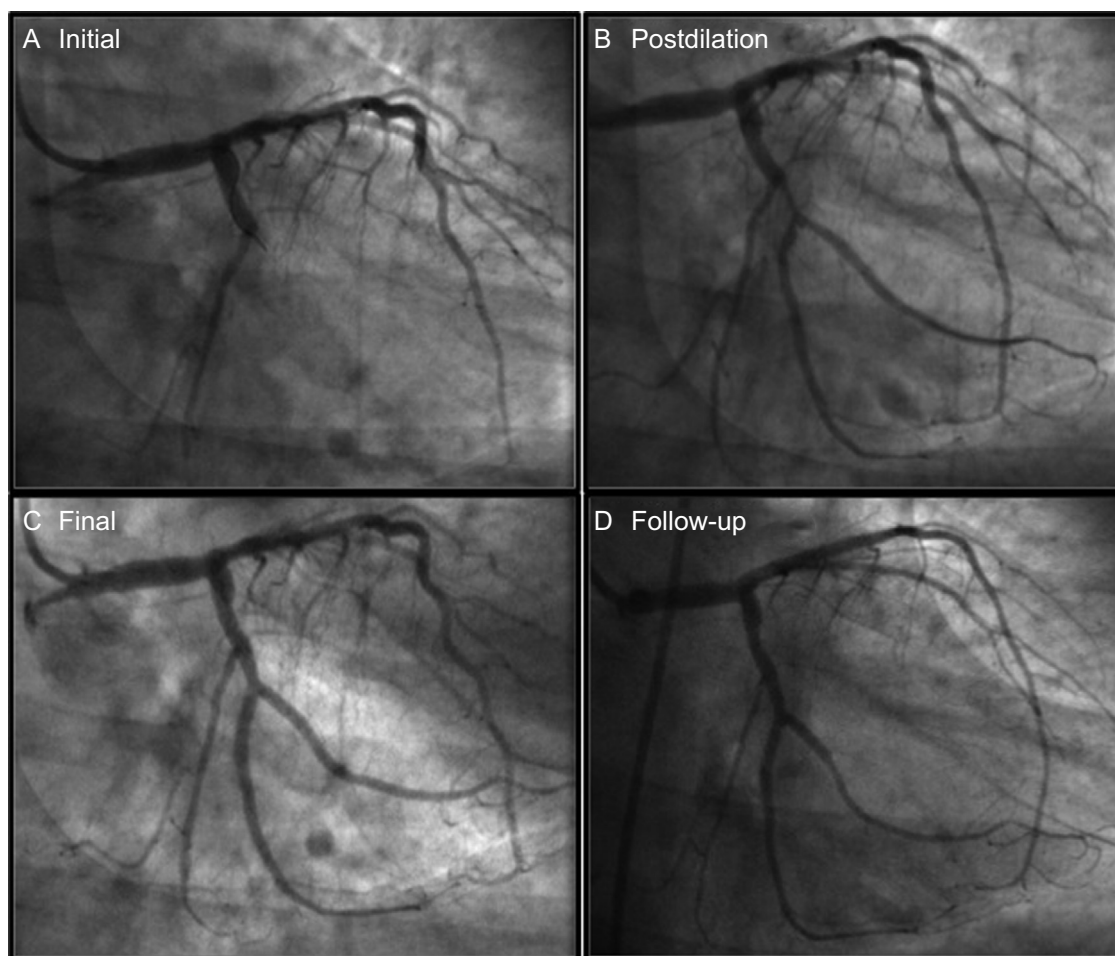
Figure 1.

Coronary angiography in a 60-year-old woman with non–ST-elevation acute coronary syndrome revealed occlusion of the first marginal branch (Figure 1A).

After predilatation, 2 branches of similar diameter were seen, with significant stenosis of the inferior branch and mild stenosis of the ostium of the superior branch (Figure 1B).

A 3 × 28-mm Absorb (Abbott Vascular, California, USA) bioabsorbable vascular scaffold was implanted in the first marginal branch toward the inferior branch. After visualization of severe stenosis of the ostium of the jailed superior branch, a second 3 × 18-mm Absorb scaffold was implanted using the Culotte technique, followed by kissing balloon dilatation with two 2.5-mm NC (noncompliant) balloons to

6 atmospheres (to avoid overexpansion of the proximal zone) and subsequent postdilatation of the first marginal branch-inferior branch ( $3 \times 15$ -mm NC balloon) (Figure 1C).

The scheduled 12-month follow-up (Figure 1D, Figure 3, and video 2 of the supplementary material) showed adequate endothelial coverage, even in the proximal segment and at the malappositioned strut at the carina (Figure 3, arrows).

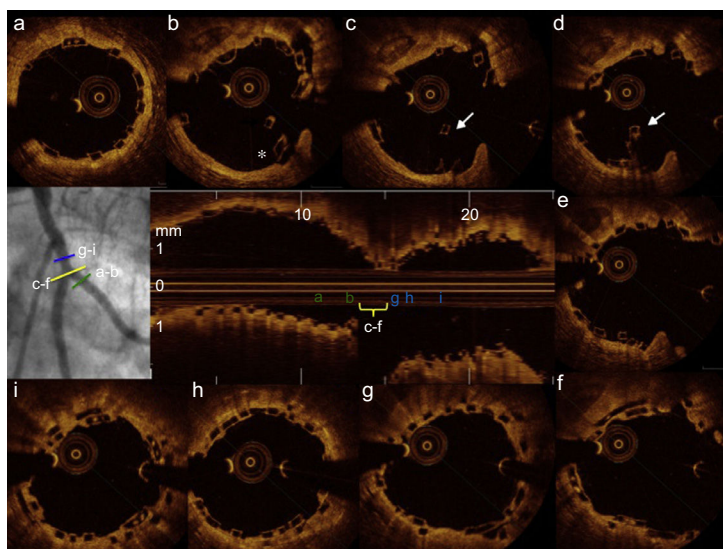
**Figure 2.**

Follow-up optical coherence tomography (Figure 2, video 1 of the supplementary material) revealed expansion and correct apposition of almost all of the struts. Some struts showed slight malapposition (Figure 2, asterisk). There was also marked malapposition of a strut possibly corresponding to a connector at the bifurcation (Figure 2, arrows).
