Image in cardiology

Culotte Technique With a Bioresorbable Vascular Scaffold: 12 Months' Follow-up

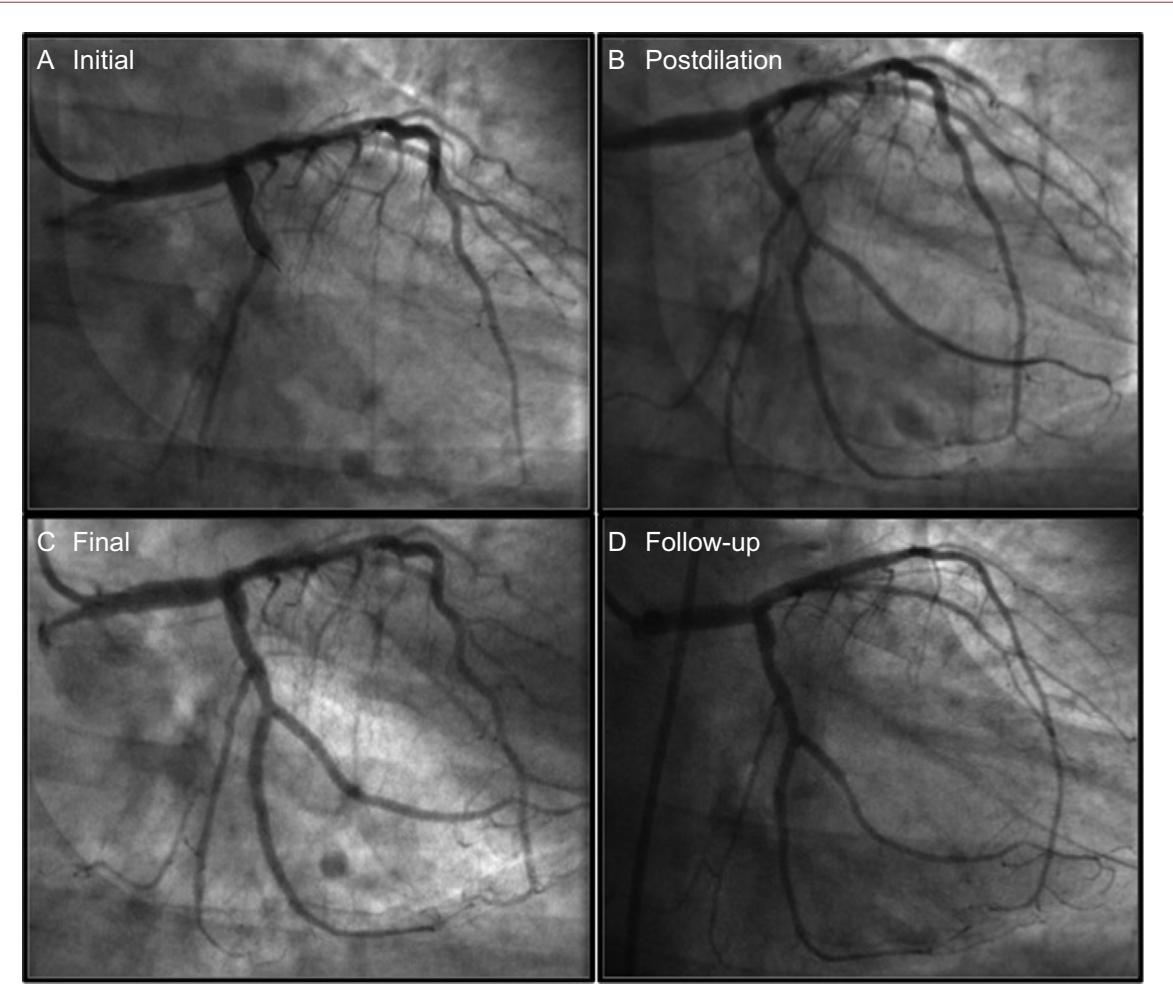
Figure 1.

Coronary angiography in a 60-year-old woman with non–ST-elevation acute coronary syndrome revealed occlusion of the first marginal branch (Figure 1A).

After predilatation, 2 branches of similar diameter were seen, with significant stenosis of the inferior branch and mild stenosis of the ostium of the superior branch (Figure 1B).

A 3 \times 28-mm Absorb (Abbott Vascular, California, USA) bioabsorbable vascular scaffold was implanted in the first marginal branch toward the inferior branch. After visualization of severe stenosis of the ostium of the jailed superior branch, a second 3 \times 18-mm Absorb scaffold was implanted using the Culotte technique, followed by kissing balloon dilatation with two 2.5-mm NC (noncompliant) balloons to

6 atmospheres (to avoid overexpansion of the proximal zone) and subsequent postdilatation of the first marginal branch-inferior branch (3×15 -mm NC balloon) (Figure 1C).

The scheduled 12-month follow-up (Figure 1D, Figure 3, and video 2 of the supplementary material) showed adequate endothelial coverage, even in the proximal segment and at the malappositioned strut at the carina (Figure 3, arrows).

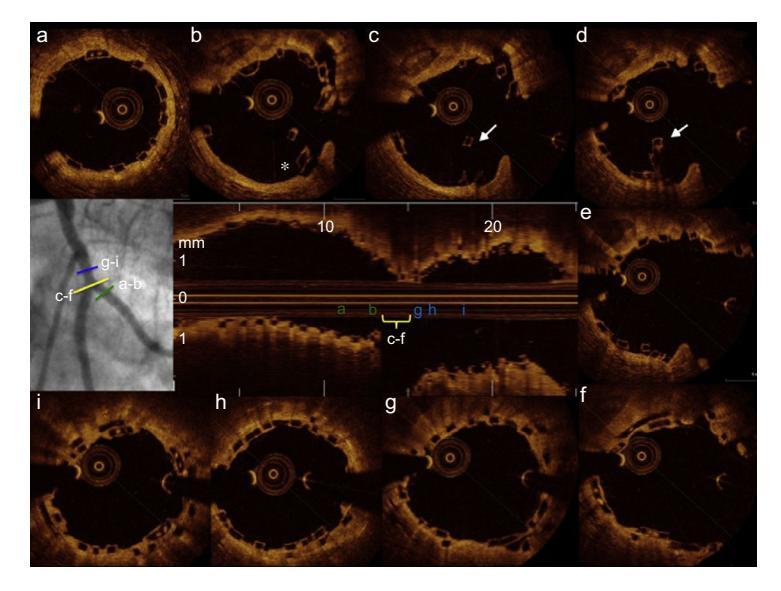
Figure 2.

Follow-up optical coherence tomography (Figure 2, video 1 of the supplementary material) revealed expansion and correct apposition of almost all of the struts. Some struts showed slight malapposition (Figure 2, asterisk). There was also marked malapposition of a strut possibly corresponding to a connector at the bifurcation (Figure 2, arrows).
