IMAGES IN CARDIOLOGY

Fibrocalcific Septal Mass With Subaortic Membrane

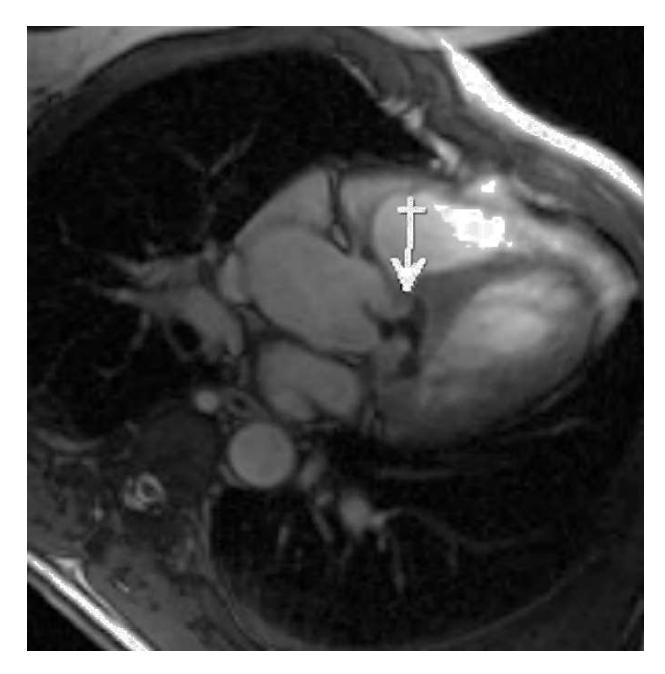
Figure 1.

A 46-year-old patient who consulted for palpitations was found to have isolated repeated premature ventricular beats on the electrocardiogram. Transthoracic electrocardiography showed a subaortic membrane that did not generate a gradient in that area, as well as a slightly dilated ascending aorta (maximum diameter, 44 mm). To complete the study, cardiac magnetic resonance imaging was performed with dynamic gradient echo sequences (fast-imaging employing steady-state excitation [FIESTA] technique). A hypointense image consistent with a fibrocalcific mass was detected in the left ventricular outflow tract (LVOT), which ran in a subaortic course to the valve plane and continued along the intramyocardial interventricular septum. The patient had a tricuspid aortic valve that was functionally bicuspid due to calcification of the commissure between the left and right coronary leaflets. The 5-chamber view at the level of the LVOT (Figure 1)

shows the subaortic membrane (arrow) continuing to the valve plane. The extension of the fibrocalcification along the long axis of the interventricular septum (arrow) is seen in Figure 2. Because there were no relevant symptoms and no gradient indicating hemodynamic compromise, these imaging findings led us to take a conservative approach consisting in imaging surveillance every 6 months to monitor the evolution of the condition.
