Imaging Techniques in Chagas Disease

Patricia Mahía, a Víctor Pineda, b and Hug Cuéllar b aServicio de Cardiología, Hospital Universitario Vall d'Hebron, Barcelona, Spain bServicio de Radiología, Hospital Universitario Vall d'Hebron, Barcelona, Spain

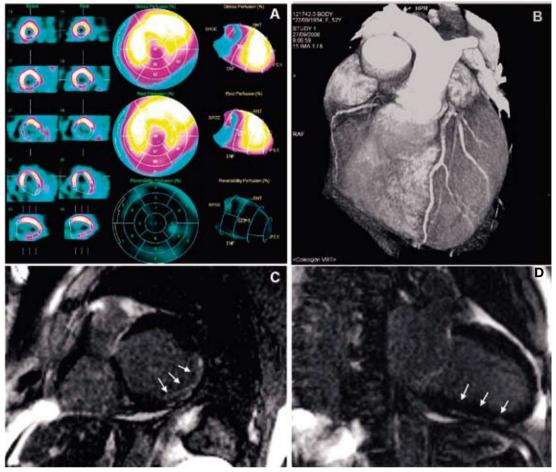
Figure.

Cardiac involvement is the most serious complication of Chagas disease. The new, noninvasive imaging techniques have extended the diagnostic options in this condition. Computed tomography (CT) coronary angiography enables a coronary etiology to be ruled out, and detection of myocardial fibrosis by cardiac magnetic resonance imaging (CMRI) with late gadolinium enhancement is a proven marker of subclinical involvement with prognostic value, showing an inverse correlation with the ejection fraction (EF). Development of fibrosis predominates in territories of distal circulation, particularly the inferolateral regions. We present the case of a 52-year-old patient from Peru with hypertension and dyslipidemia who had a history of palpitations and progressively increasing dyspnea. The electrocardiogram showed sinus rhythm with left anterior hemiblock and right bundle branch block. Echocardiography revealed a dilated left ventricle (LV) and EF of 24%. Based on a diagnosis of dilated cardiomyopathy of uncertain etiology and considering the risk factors, singlephoton emission CT (SPECT) was performed. The results were clinically and electrically negative for ischemia, and showed a fixed inferior defect (Figure, A). A noninvasive approach with CT and CMRI was used to investigate the perfusion defect. Coronary disease was ruled out (Figure, B) and fibrosis was detected in the affected territory (Figures, C and D). These tests enabled a suspected diagnosis of Chagas disease to be established, which was confirmed by positive serology for Trypanosoma cruzi. This case illustrates the usefulness of noninvasive imaging techniques in cardiac involvement by Chagas disease and provides a new diagnostic and prognostic approach to consider in the clinical management of this condition.
