IMAGES IN CARDIOLOGY

Stent Pseudo restenosis. Diagnosis Using Intravascular Ultrasound

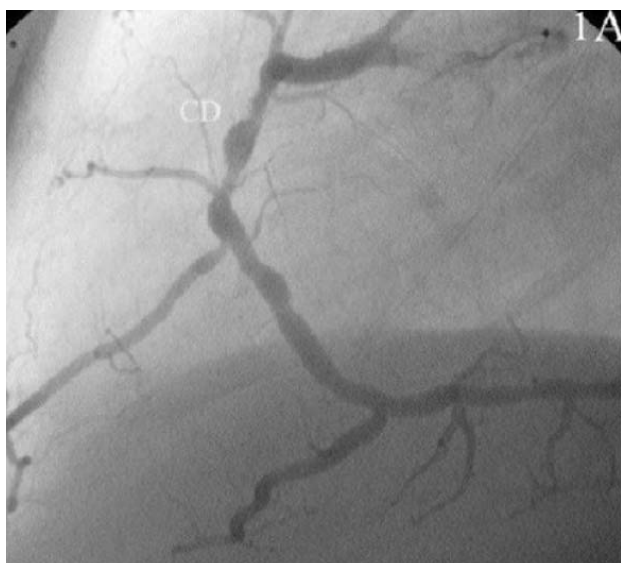
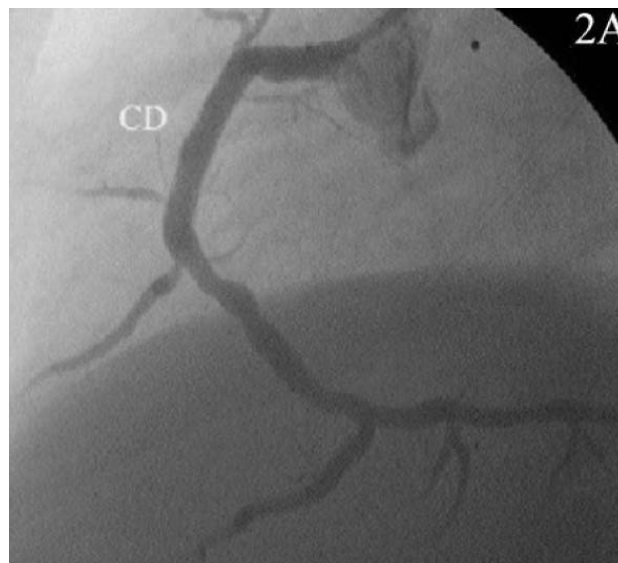
Fig. 1.

The patient was referred to our hospital where cardiac catheterization showed distal LAD disease, similar to that seen before, and a lesion in the RCA stent (Figure 1A). Moreover, there was an inconclusive image of contrast leakage outside the limits of the stent. Intracoronary ultrasound showed a 2.5-mm permeable stent without intimal proliferation. Nevertheless, failed apposition of the struts to the wall of the vessel, which measured 4 mm in diameter, was evident (Figure 1B). The stent was dilated with a 4 20-mm balloon at high-pressure and a small proximal dissection occurred. A 4 28-mm stent was then implanted, with good angiographic results
