## IMAGES IN CARDIOLOGY

### Multiple Penetrating Aortic Ulcers With Magnetic Resonance Imaging

Estornell J, et al. Multiple Penetrating Aortic Ulcers With Magnetic Resonance Imaging

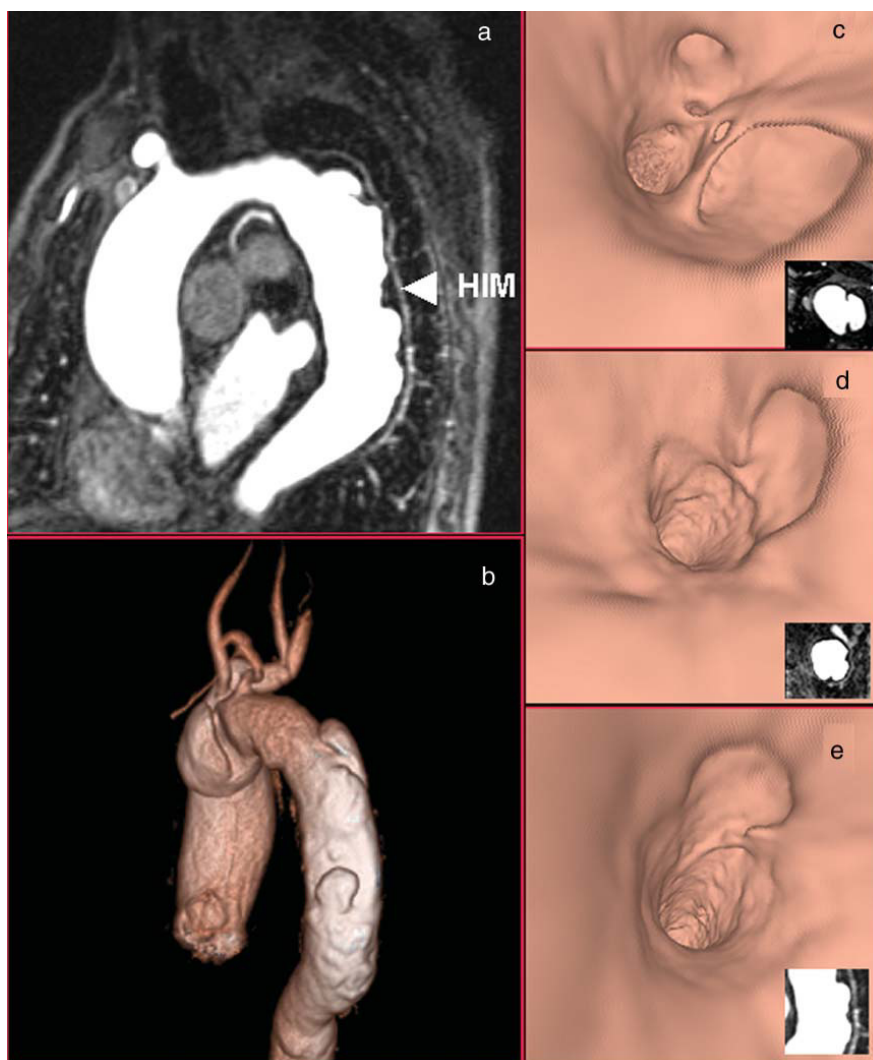
Fig. 1.

Magnetic resonance (MR) imaging was performed to investigate suspected acute aortic syndrome. The black-blood and bright-blood unenhanced anatomic sequences showed multiple penetrating aortic ulcers producing saccular aneurysms associated with an intramural hematoma (IMH) in the descending thoracic aorta. Gadolinium-enhanced MR angiography with

maximum intensity projection (MIP) reconstructions (Figure 1a) and volume rendering (VR) (Figure 1b) with virtual endoscopic vision (Figures 1 c, d, and e) confirmed these findings.

The symptoms resolved with antihypertensive drug treatment and there were no new episodes of chest pain. Follow-up magnetic resonance imaging two months after hospital discharge showed a decrease in the size of the hematoma.
