LETTERS TO THE EDITOR

Pseudoaneurysm of the Pulmonary Autograft Following the Ross Procedure

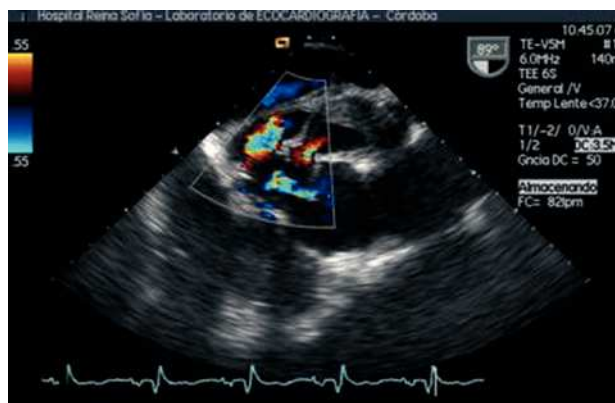
Figure 2. Transesophageal echocardiographic image at 90°, in which color Doppler reveals the shunt of the pseudoaneurysm with the left ventricular outflow tract through two points of entry.

the point of entry in the inferior suture of the autograft in the noncoronary sinus, with extension to the left coronary sinus, compromising the origin of the left coronary artery (Figure 2). Ultimately, the patient underwent surgery with aortic valve placement (Bono-Bentall).

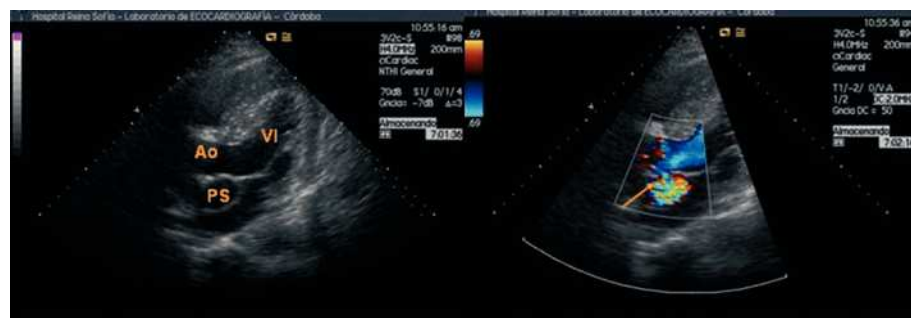
Figure 1. Two transthoracic echocardiography images in a longitudinal parasternal view. The first shows a pulsatile, retroaortic outpouching consistent with pseudoaneurysm; in the second, color Doppler ultrasound reveals flow through the point of entry (arrow). Ao indicates aorta; PS, pseudoaneurysm; LV, left ventricle.
