## LETTERS TO THE EDITOR

### Pseudoaneurysm of the Pulmonary Autograft Following the Ross Procedure

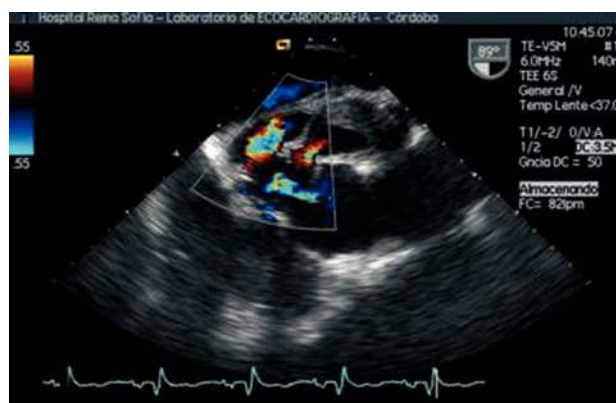
**Figure 2.** Transesophageal echocardiographic image at 90°, in which color Doppler reveals the shunt of the pseudoaneurysm with the left ventricular outflow tract through two points of entry.

the point of entry in the inferior suture of the autograft in the noncoronary sinus, with extension to the left coronary sinus, compromising the origin of the left coronary artery (Figure 2). Ultimately, the patient underwent surgery with aortic valve placement (Bono-Bentall).

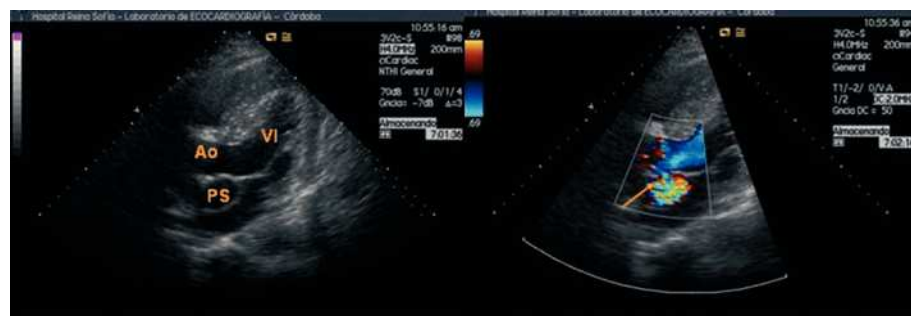
**Figure 1.** Two transthoracic echocardiography images in a longitudinal parasternal view. The first shows a pulsatile, retroaortic outpouching consistent with pseudoaneurysm; in the second, color Doppler ultrasound reveals flow through the point of entry (arrow). Ao indicates aorta; PS, pseudoaneurysm; LV, left ventricle.

The second case was a 37-year-old man who successfully underwent the Ross procedure for severe rheumatic aortic regurgitation. He received regular follow-up, with the two-year transthoracic echocardiogram showing a pulsatile retroaortic outpouching with interior flow, that was not present in the echocardiogram the previous year and was consistent with a pseudoaneurysm of the autograft. In addition, he had mild dilation of the aortic ring that caused mild aortic regurgitation. Transesophageal echocardiography disclosed
