Image in cardiology

Right and left coronary chimney stenting during valve-in-valve procedure

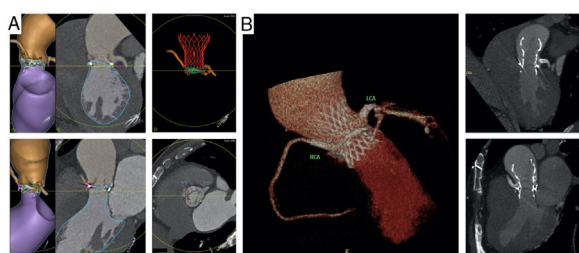
Figure 1.

A 76-year-old man was admitted with heart failure secondary to a failed 25-mm Mitroflow (Sorin Group USA Inc, United States) valve with severe aortic regurgitation and reduced left ventricular ejection fraction. The Heart Team decision was to perform a valve-in-valve procedure (ViV) with pre-emptive positioning of stents in the left main (LM) and right coronary artery (RCA). A preprocedural computed tomography scan enabled us to identify anatomical features (5.7 mm LM height, 8.5 mm RCA height and shallow sinuses of Valsalva with a valve distance to coronaries < 4 mm) associated with increased risk for coronary compromise during ViV (figure 1A; video 1 of the supplementary data).

During valve deployment, the patient experienced acute hypotension and complete atrioventricular block due to RCA obstruction. Consequently, the stent was withdrawn and deployed with immediate hemodynamic normalization. The CoreValve (Medtronic, United States) prosthesis was released completely with significant underexpansion. As the Mitroflow leaflet seemed to be displaced close to the LM ostium following CoreValve deployment, an LM stent was deployed as a preventative measure. Valve postdilation was successfully performed using a kissing technique with simultaneous inflation of the aortic balloon and both coronary stent balloons (figure 2; video 2 and video 3 of the supplementary data). At 3 months of follow-up, the patient was in New York Heart Association class I with preserved left ventricular ejection fraction, and a computed tomography scan ruled out stent complications (figure 1B).
